NATIONAL PROGRAM FOR INSPECTION OF NON-FEDERAL DAMS
GEORGIATVILLE POND DAM. (U) CORPS OF ENGINEERS WALTHAM
MA NEW ENGLAND DIV APR 79

GEORGIAVILLE POND DAM

DOCUMENT IDENTIFICATION
APR 1979

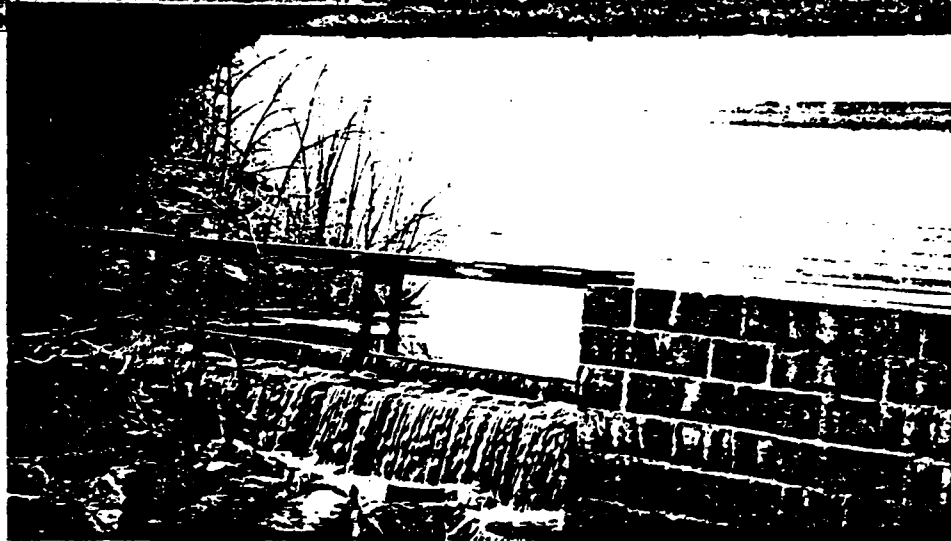
#126 GEORGIAVILLE - LOOKING WEST SHOWS SPILLWAY SOUTH OF GATE-HOUSE WITH 12" FLASH BOARDS IN PLACE TODAY.
12/2/47

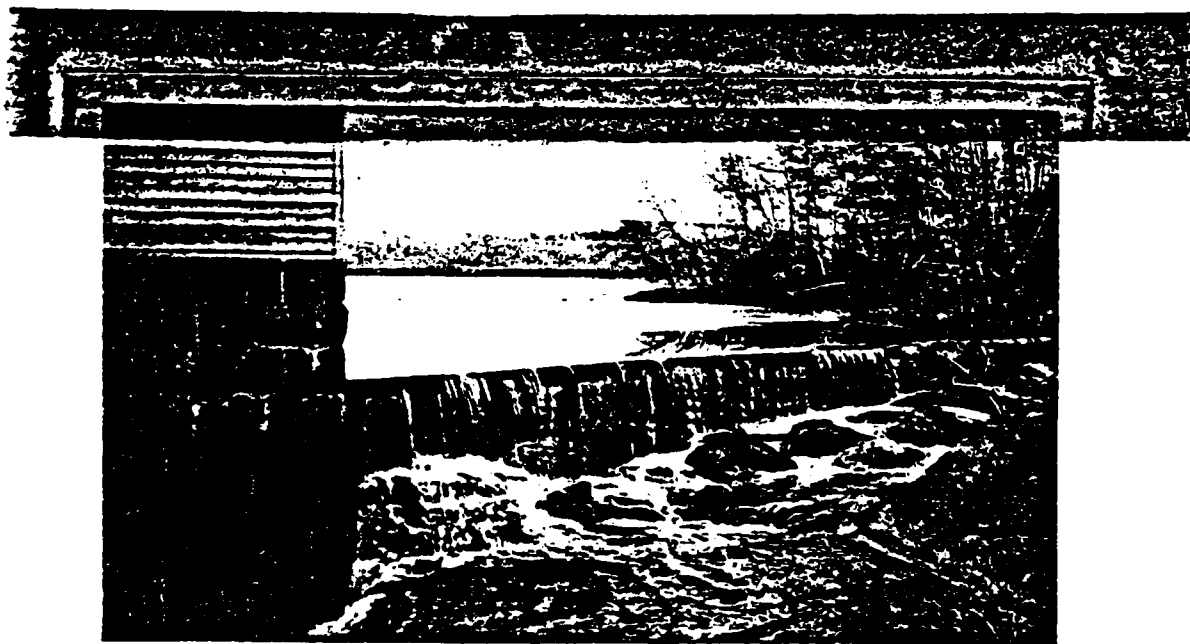
#126 GEORGIAVILLE—LOOKING N W SHOWS SPILLWAY NORTH OF GATE HOUSE. 12/2/47
